Extreme Makeover

Residential
Exterior
\$100-200K

Mission

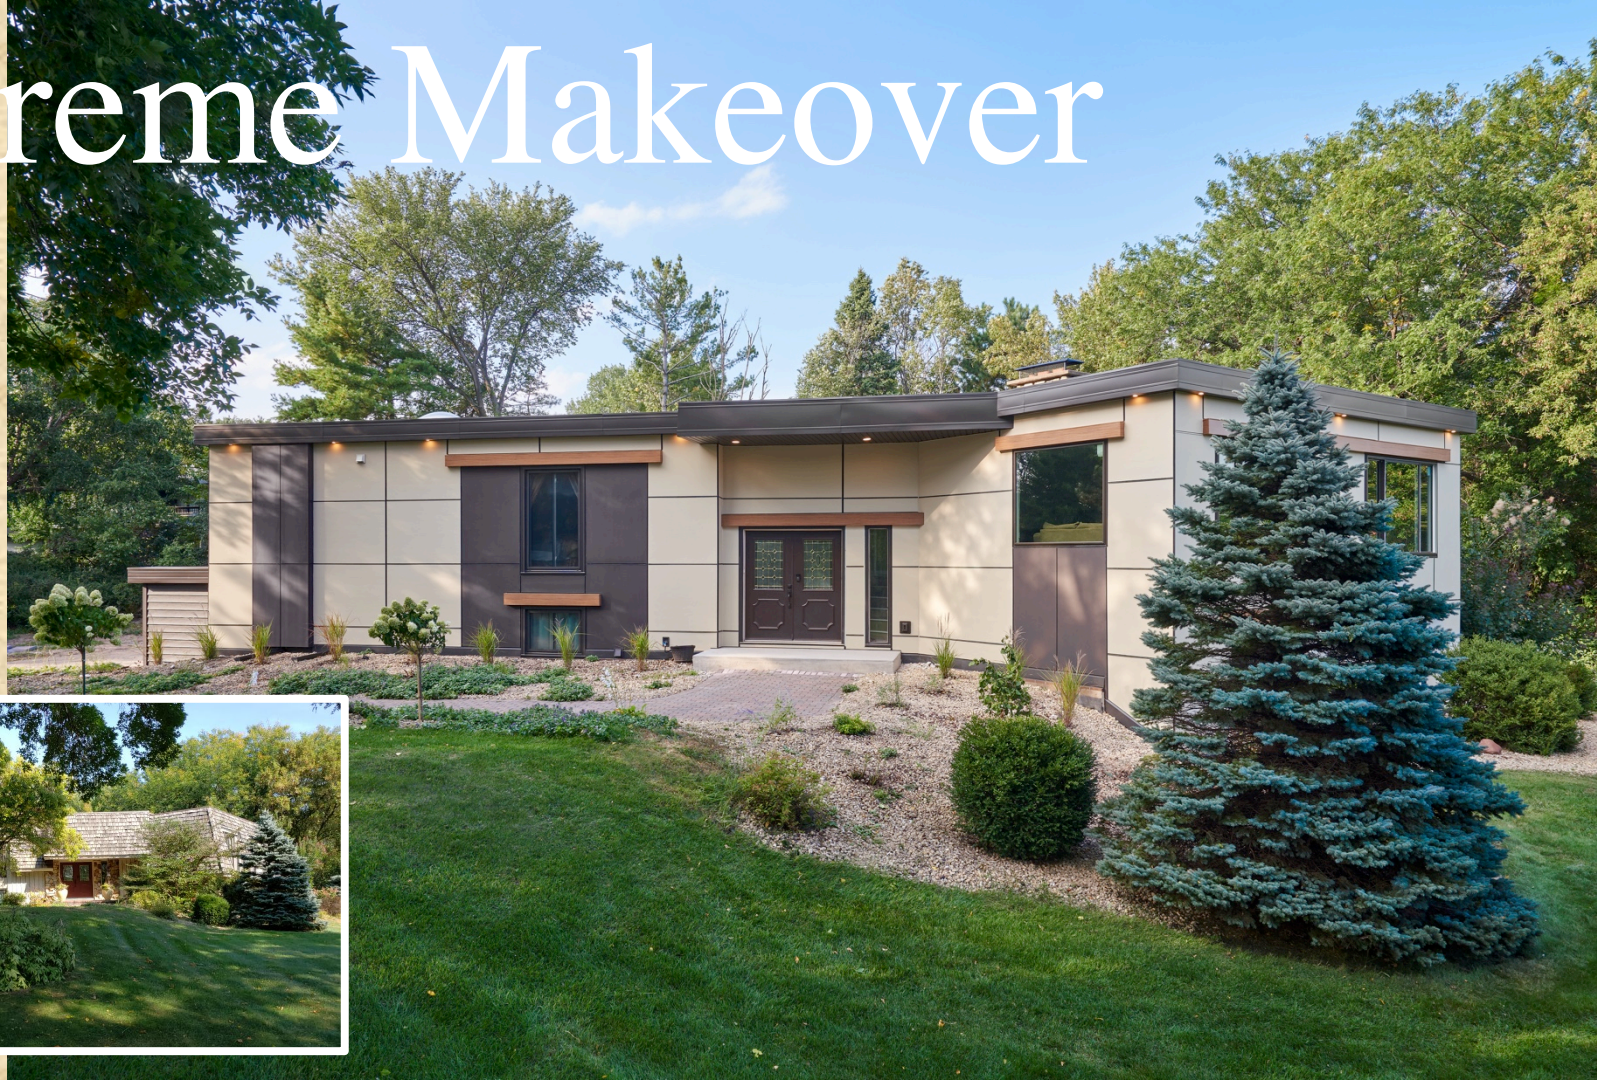
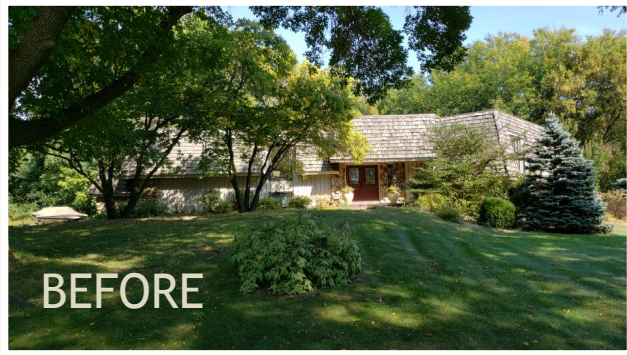
BEFORE

These clients wanted to enlarge and transform the style of their dated, 1974 mansard roof home in the exclusive North Oaks Country Club community. The NARI contractor was tasked to create a bold new look in conjunction with a separate firm that added a 2-bay garage with new living space above.

The NARI member suggested a modern cubist design with a uniform parapet around the flat roof and boxed bump-outs over windows and doors. The plan not only appealed to the clients but also was endorsed by the homeowners association board. The panel concluded that the fresh style on the prominent hillside property would help to recast the somewhat dated golf course community to appeal to younger buyers, thereby raising future property values.

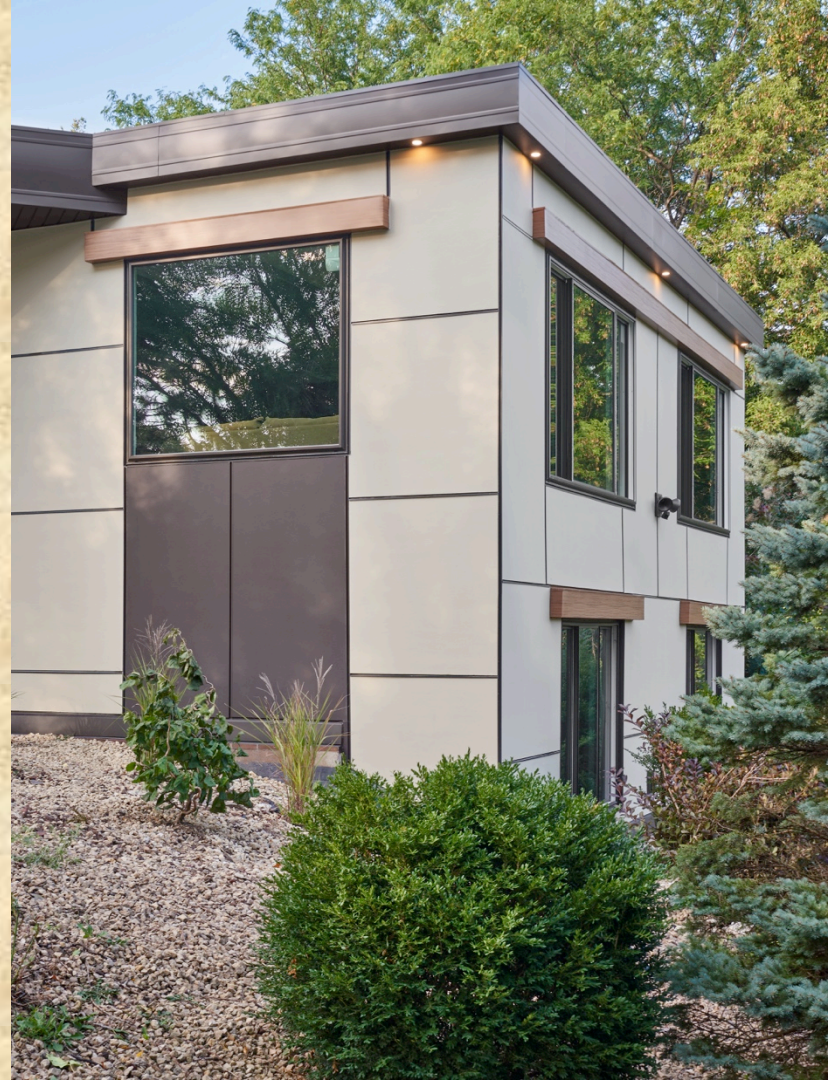
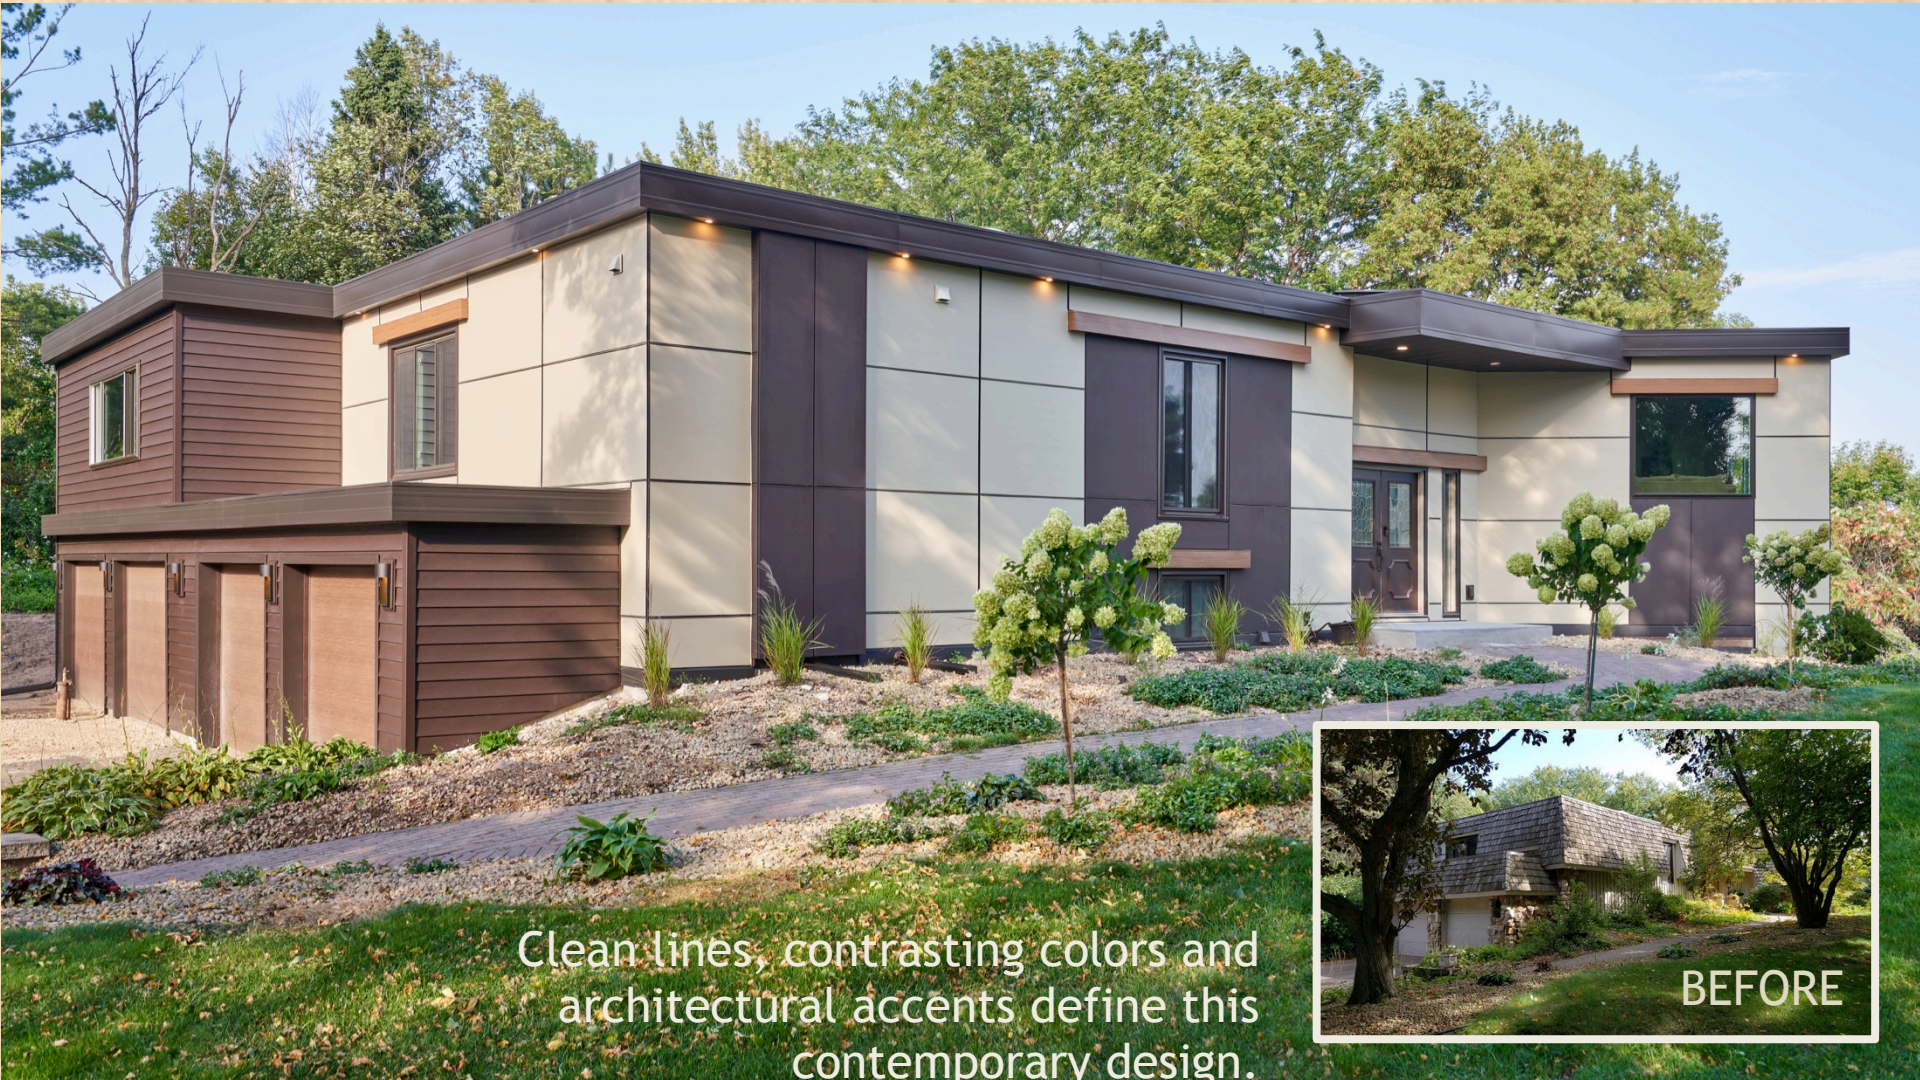
Clean lines, contrasting colors and architectural accents define this contemporary design.

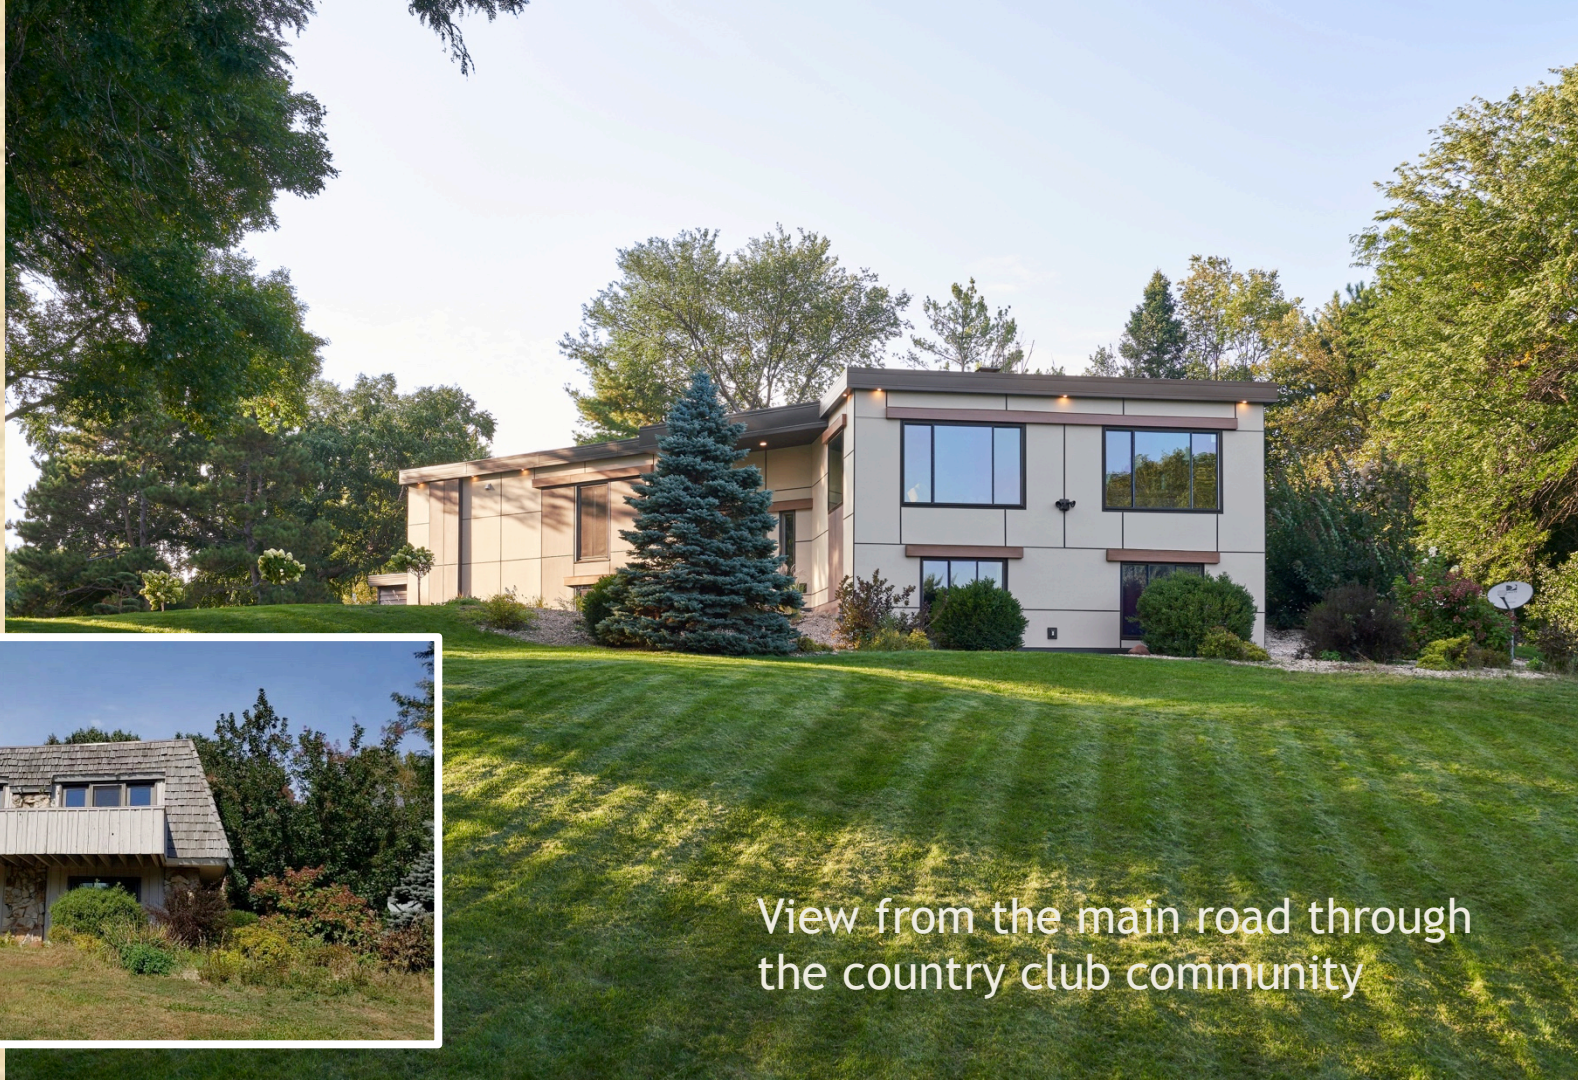
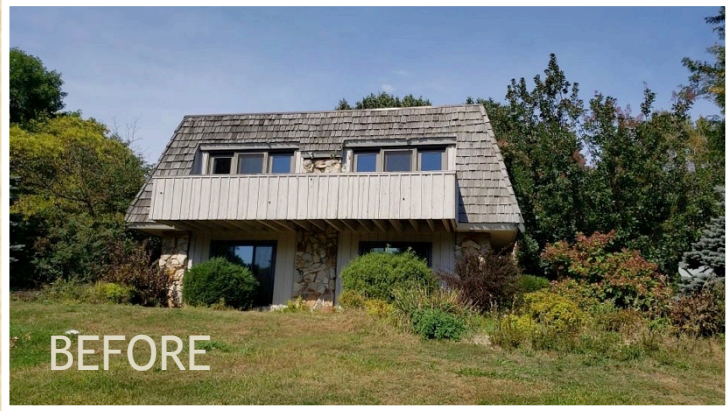
BEFORE

The old mansard roof and broad balcony had weighed down the home. The square design now soars.

View from the main road through the country club community

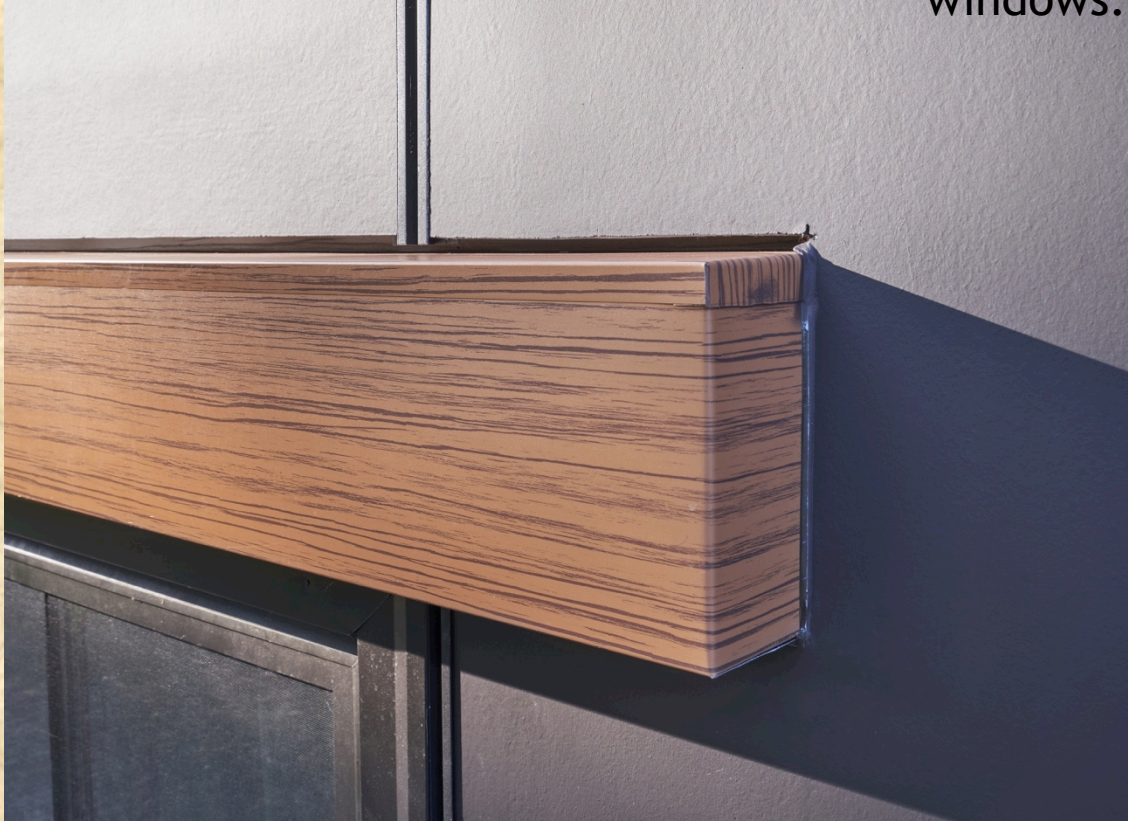
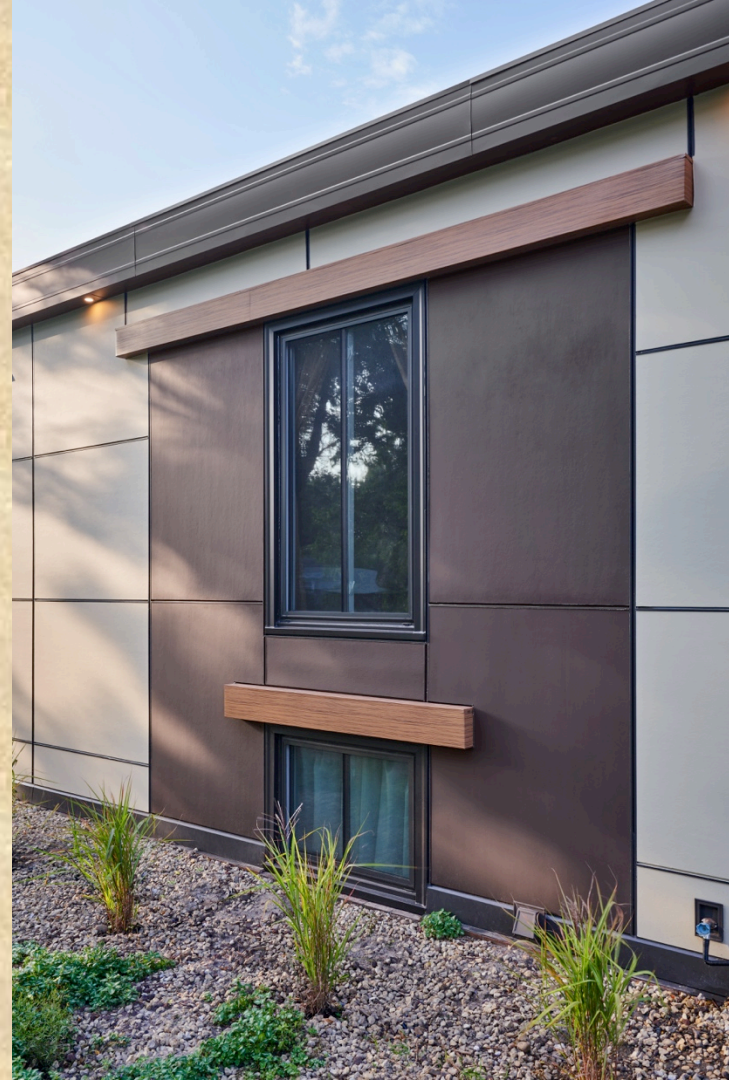
DETAILS

Metal Cedarwood bump-outs
and dark panels accent
windows.

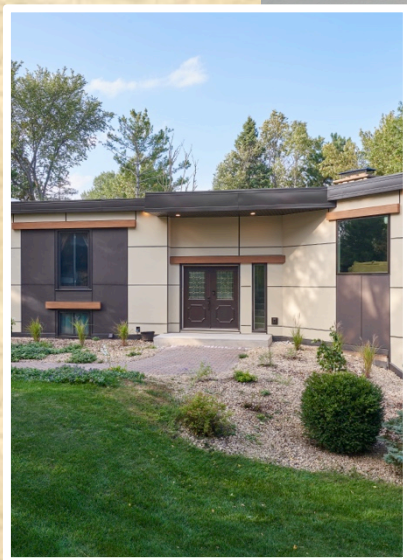
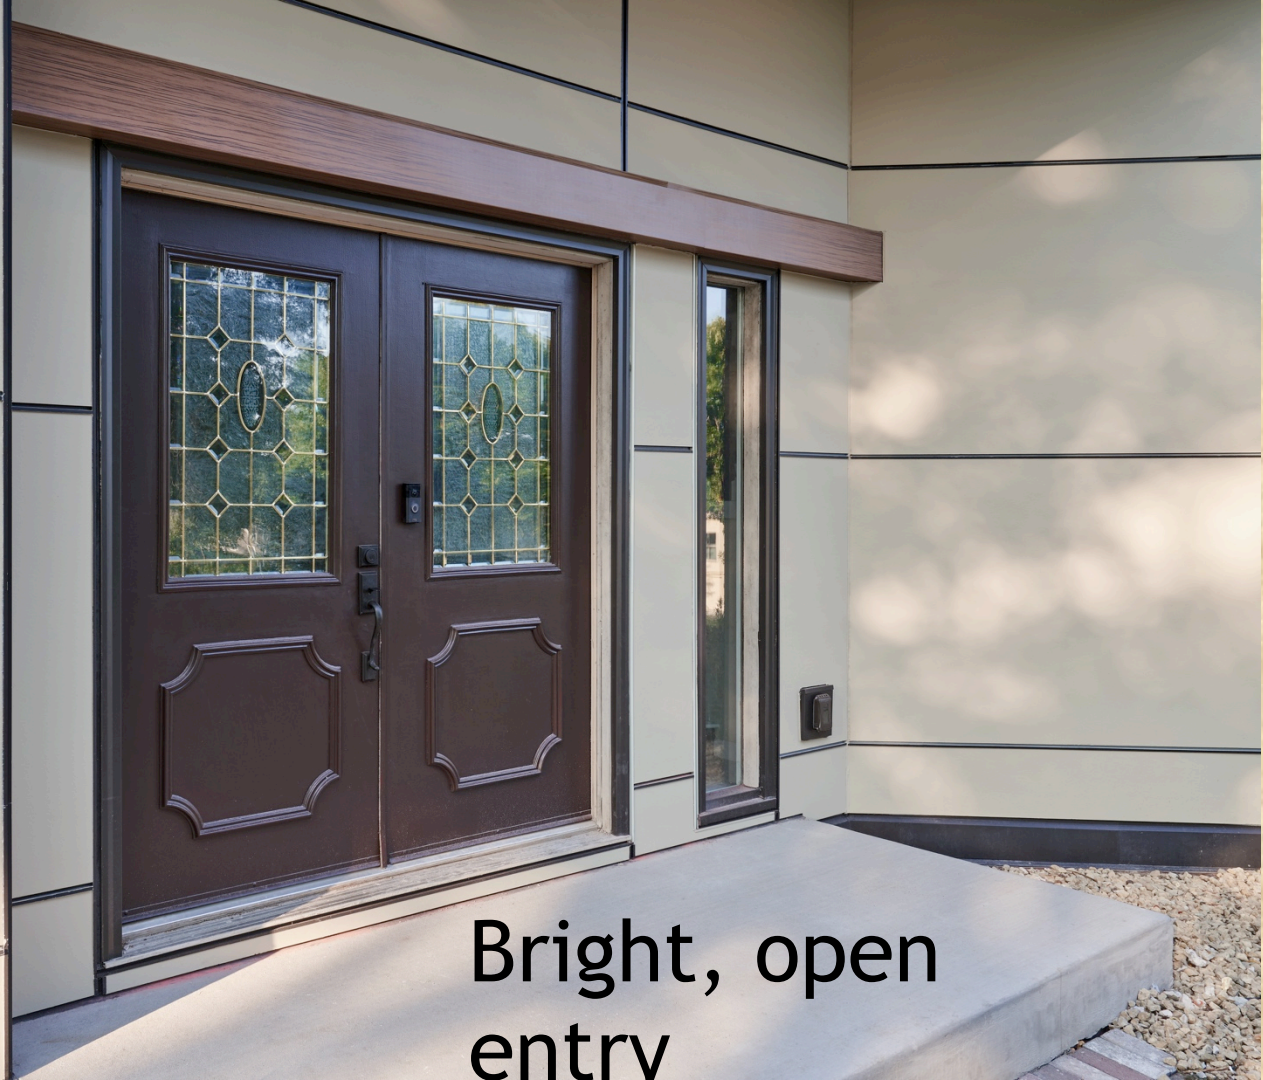
The design
frees and
emphasizes
the home's
main entry.

Bright, open
entry

The new
parapet
includes the
roof over
the screen
porch.

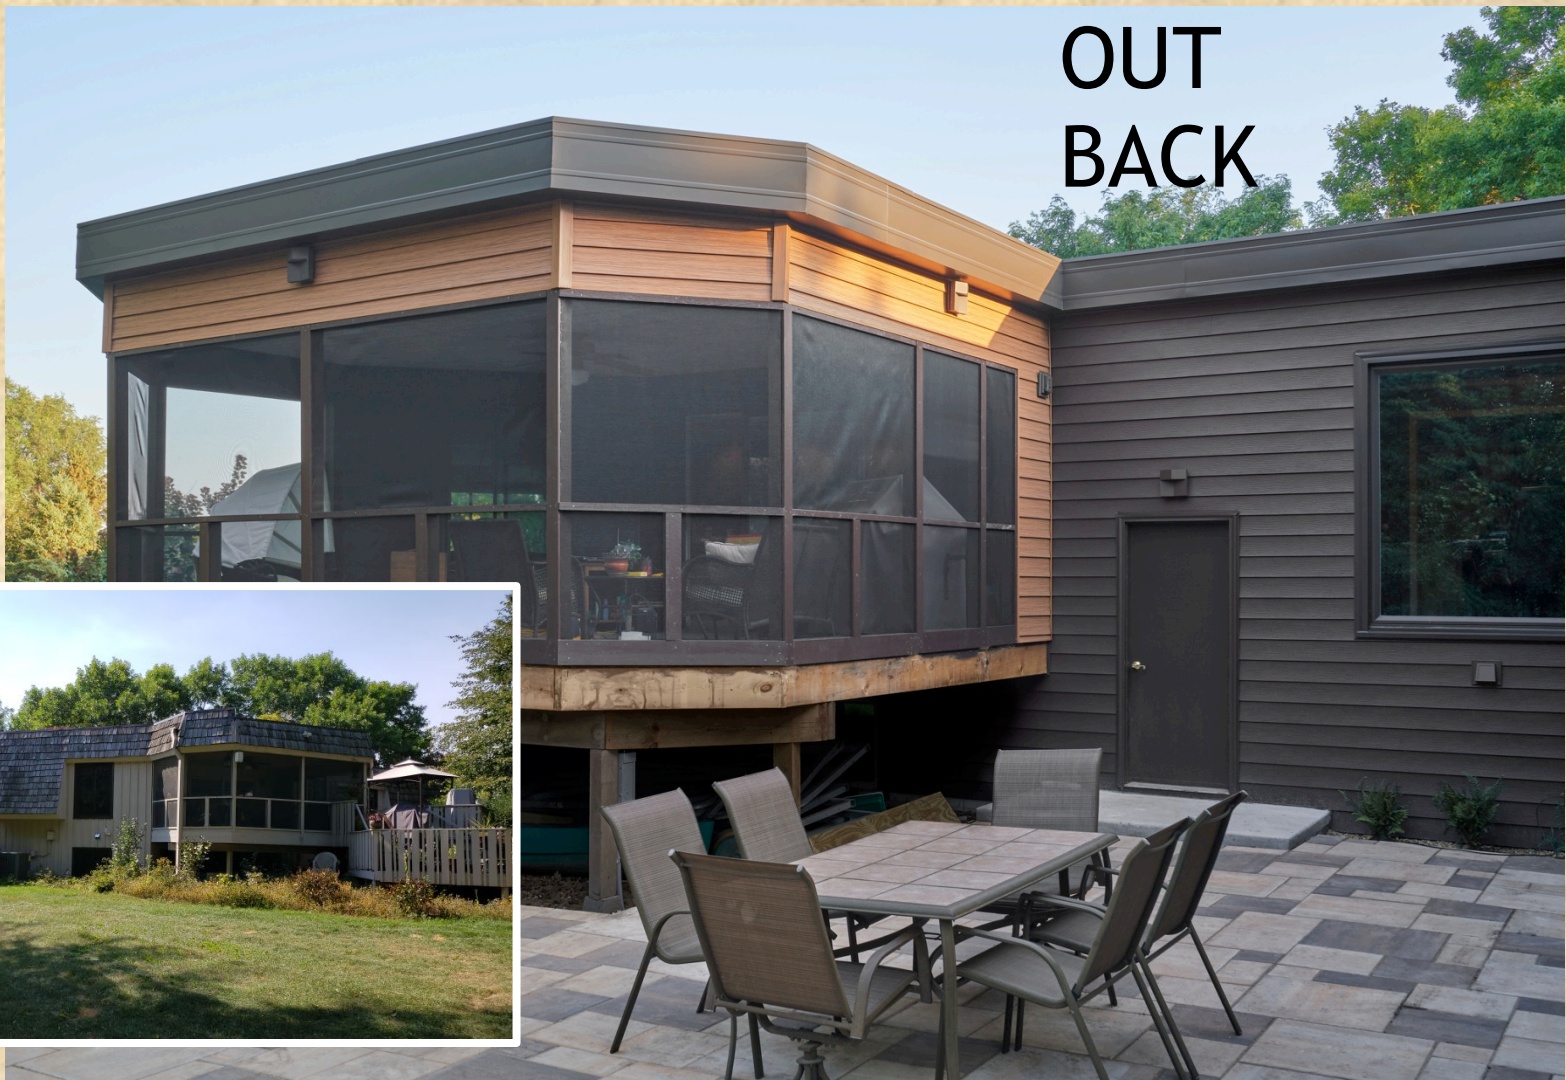
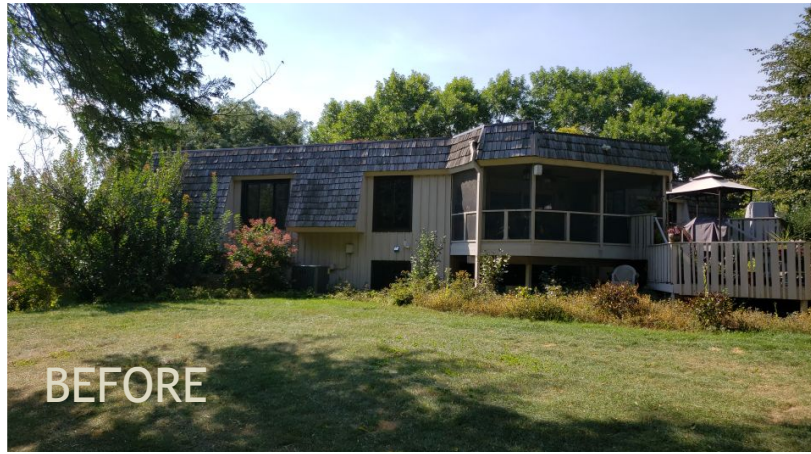
BEFORE

OUT
BACK

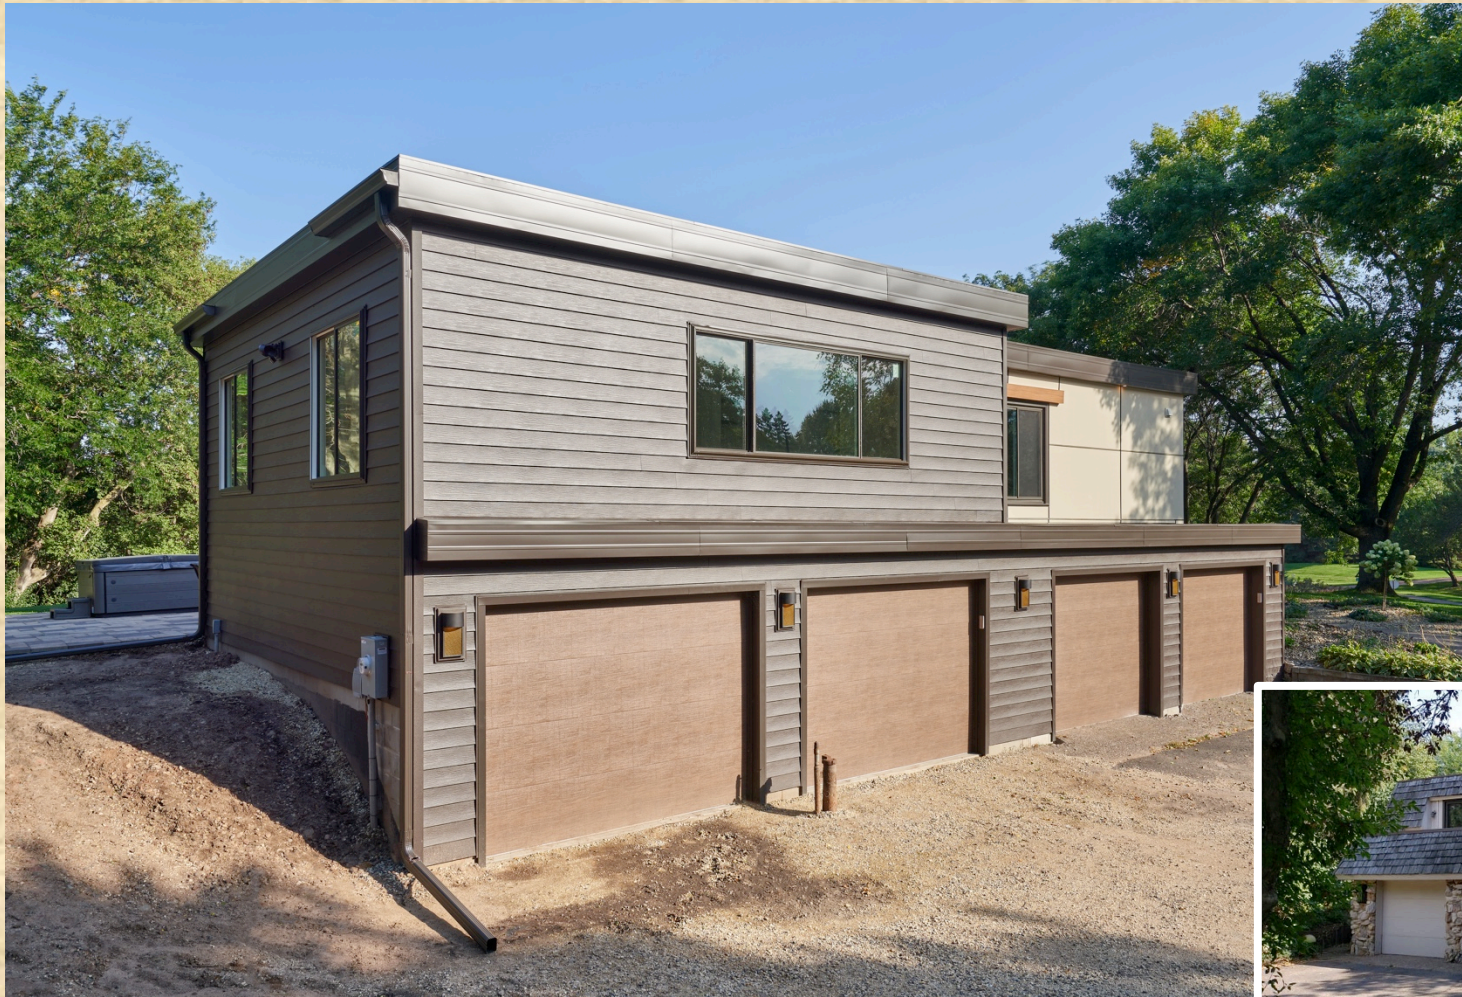
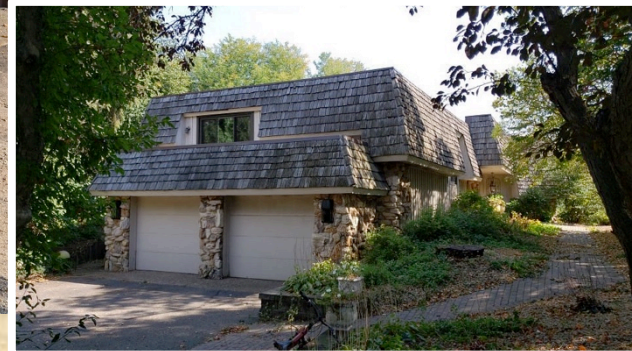
Dark steel siding defines the two-story addition and unifies the expansive four-bay garage.

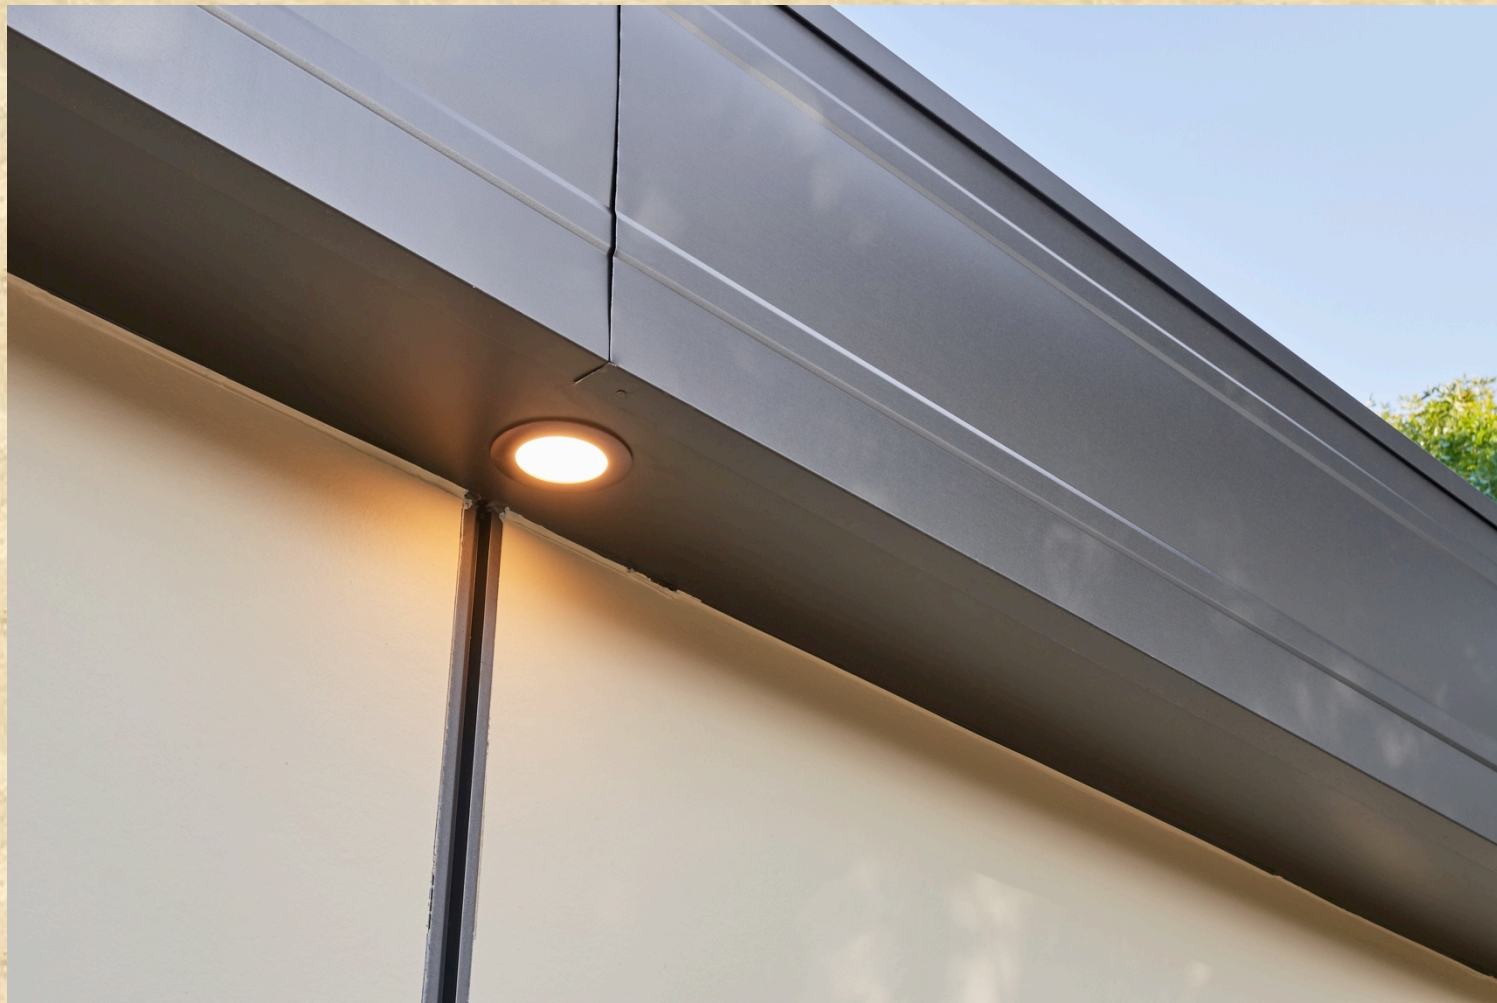
The dark parapet is dotted with LED lights. The framework was raised three inches to match the taller addition.

- ❑ Built up parapet around existing home to align with addition 3-inches higher than planned.
- ❑ Installed additional furring strips to meet 20-in. max. span for fibercement panels fasteners
when the framing shifted from 16 oc to 24

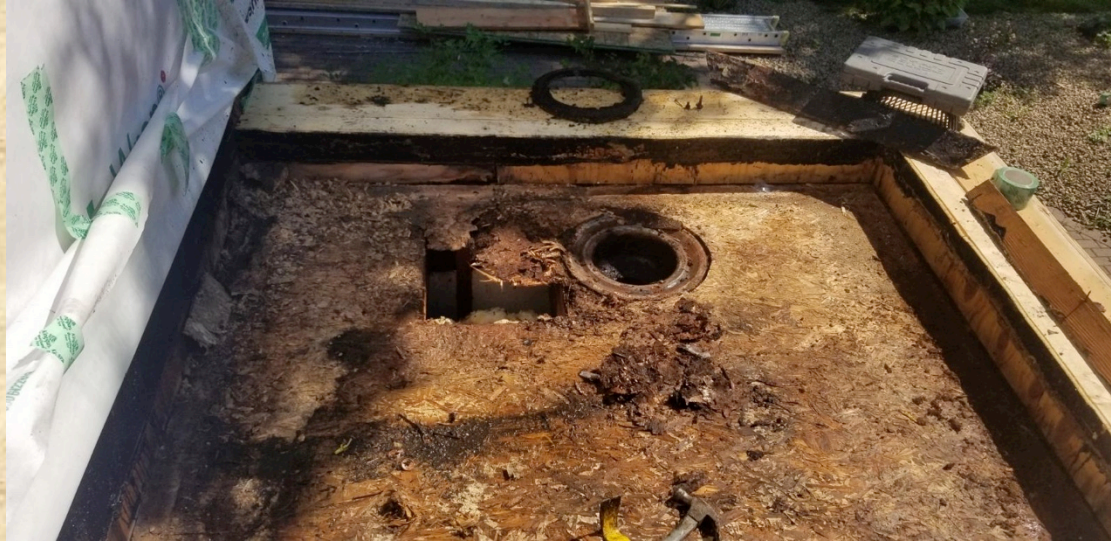
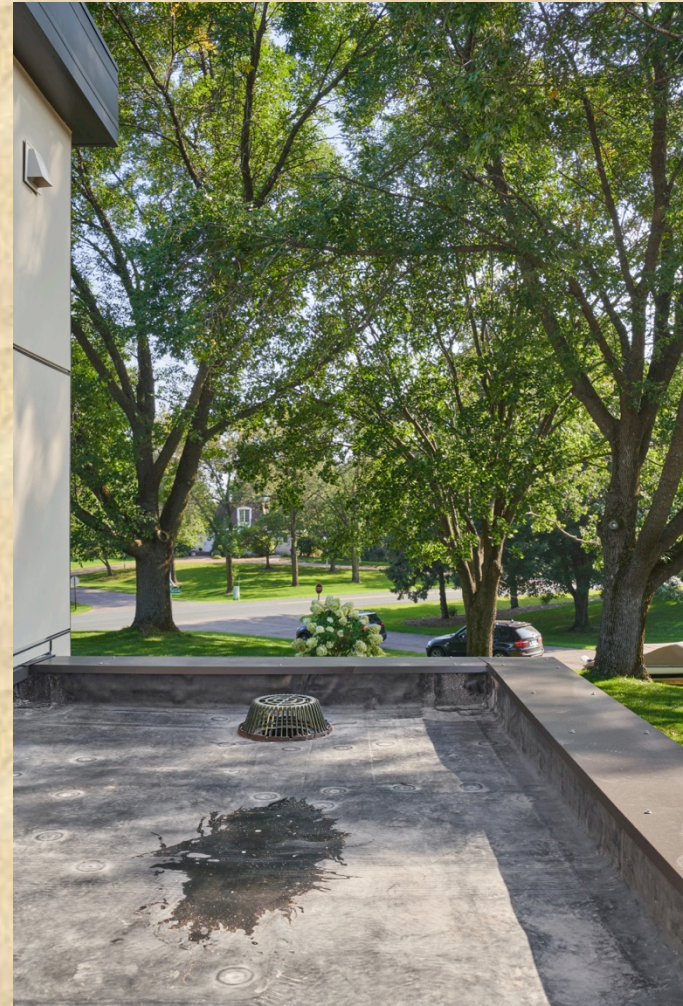
The contractor discovered a leak in the garage roof had rotted the sheathing around the drain (below). The new EPDM roof (right) and parapet overcame the problem. The installation includes proper termination bars that allow the synthetic rubber to expand and contract in extreme temperatures.

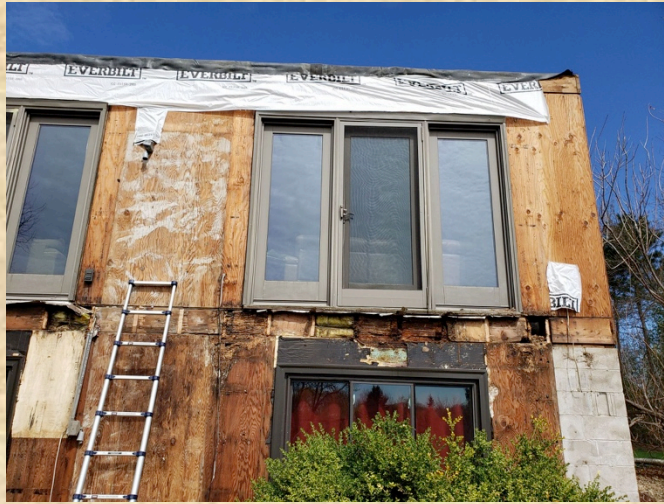
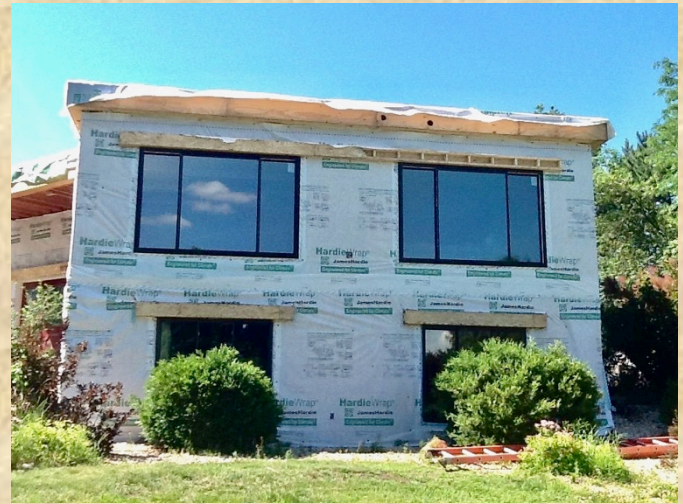
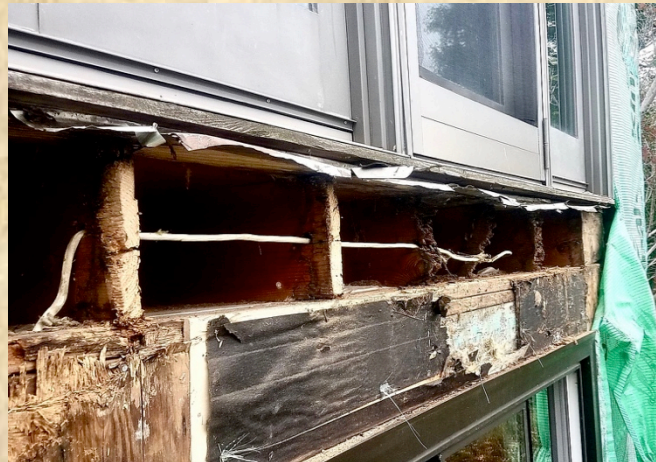
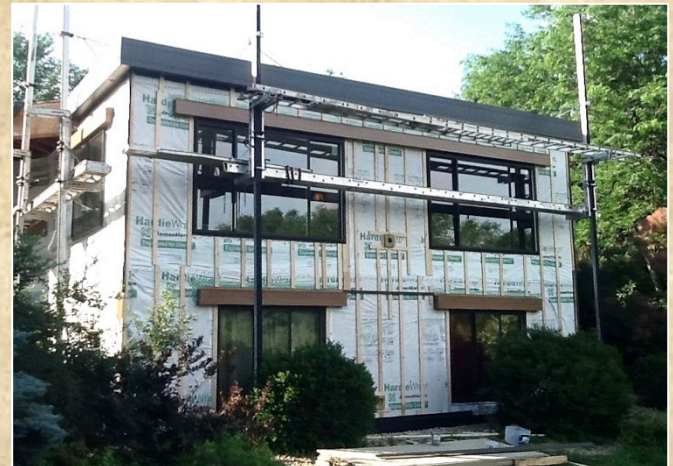
The old balcony had rotted the wood under the patio doors. New Lindsay windows replaced the doors after the structure was restored.

- ❑ Formed 3-piece cladding for bump-outs over the windows and doors and the screen porch on site.
- ❑ Rebuilt framing and installed new sheathing and wrap around existing windows and doors that had rotted from improper flashing and sealing.
- ❑ Meticulous adherence to Hardie commercial panels installation specifications including spacing of furring strips despite inconsistent stud spacing between main and upper levels.
